PASSAIC RIVER BASIN

POINT VIEW DAM

PHASE I INSPECTION REPORT

JULY 1978

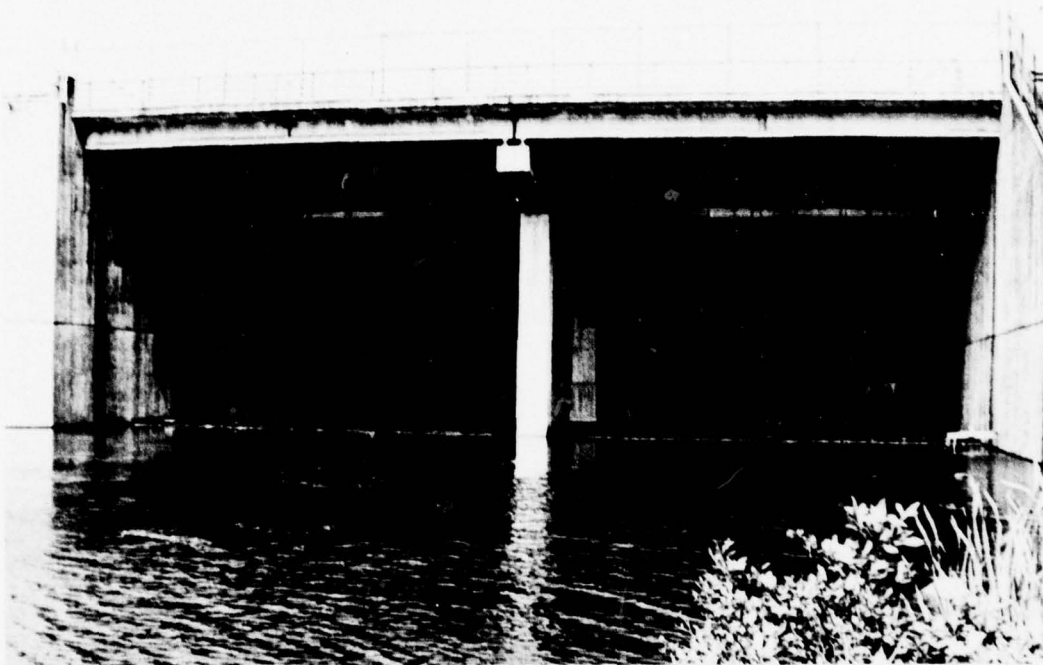
PHOTO 1

- Overall View of Dam - View North Along Downstream Slope;
Spillway Outlet in Center; Gate Control
Chamber in Upper Right Edge of Photo -
10 June 1978.
- Photo 1 - View Upstream (East at Spillway Outlet From
Southwest Bank of Lionheads Lake - 9 June 1978

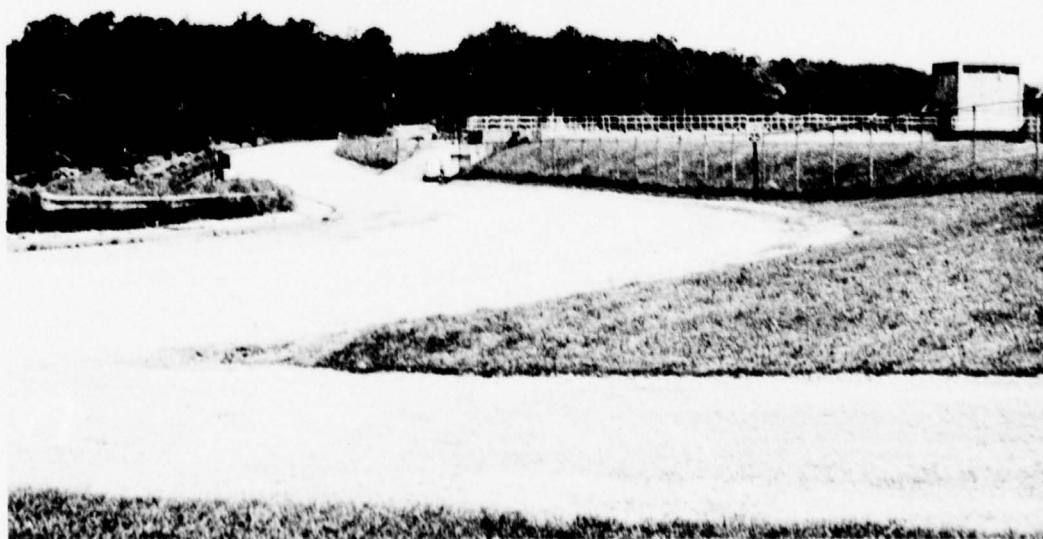
PHOTO 2

- Photo 2 - View North Along Cyanamid Drive From Left (South
Abutment of Dam; Spillway and Gate Control Chamber
in Center (Right of Station Wagon); Intake Tower
at Right Edge of Photo - 9 June 1978

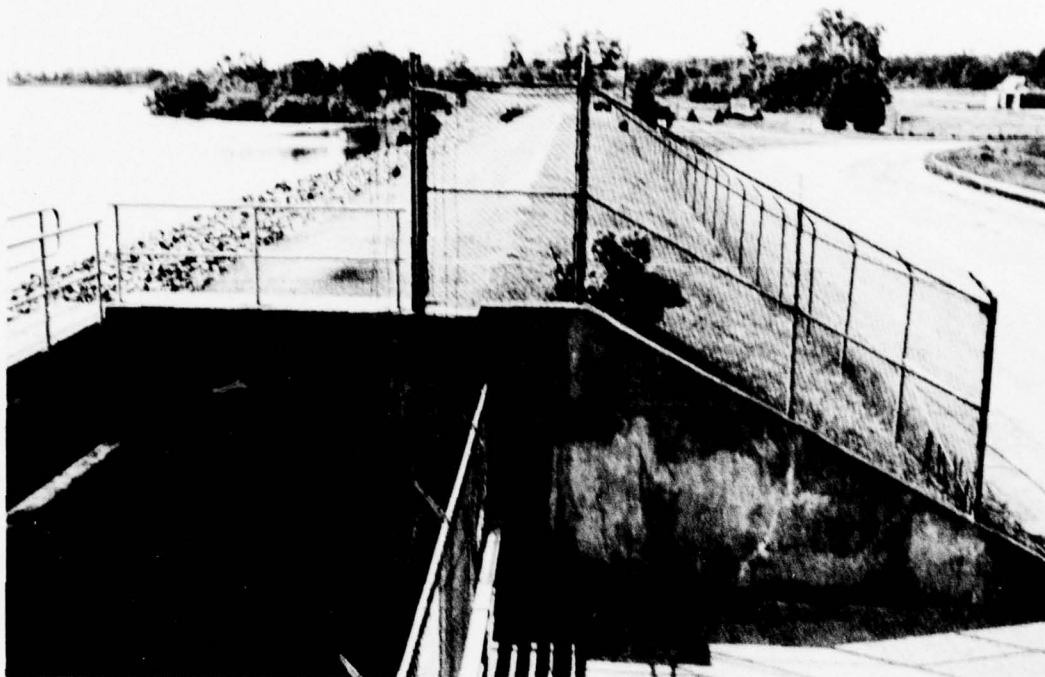
PHOTO 3

- Photo 3 - View South Along Dam Crest From Gate Control
Chamber; Ungated Spillway Section at Left -
9 June 1978
- Photo 4 - View Northeast at Right Side of Spillway (Gated
and Ungated Section) From Gate Control Chamber -
9 June 1978

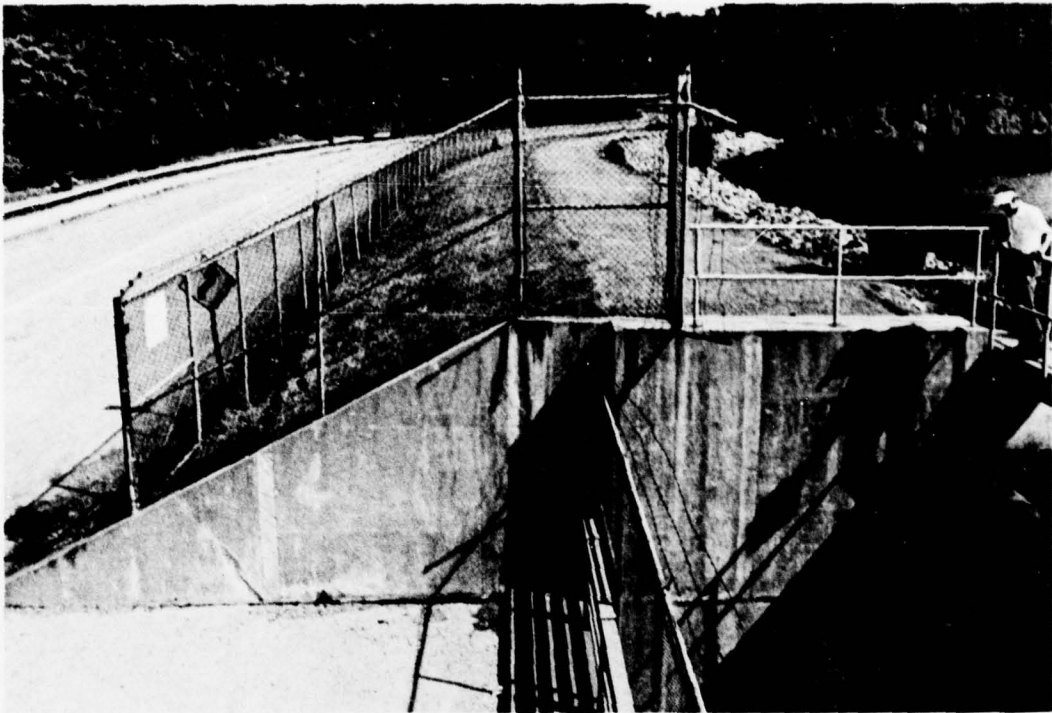
PHOTO 5

- Photo 5 - View North Along Dam Crest From Gate Control
Chamber; Ungated Spillway Section at Right -
9 June 1978
- Photo 6 - View Downstream (West) at Right (North) Side of
Spillway and Upstream Slope of Dam From Intake
Tower; Gate Control Chamber and Walkway to Intake
Tower at Left Edge of Photo - 9 June 1978

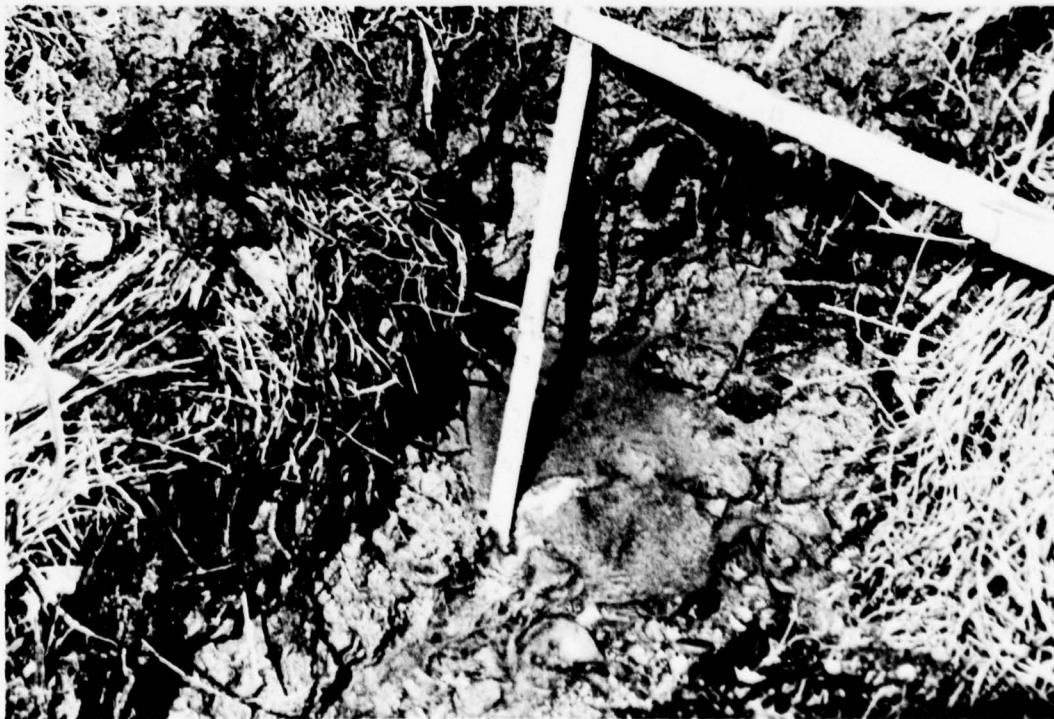
PHOTO 10

- Photo 10 - Close-up of Seepage and Sand Boils in Test Pit at
Toe of South Spillway Outlet Wing Wall (Photo 9) -
9 June 1978

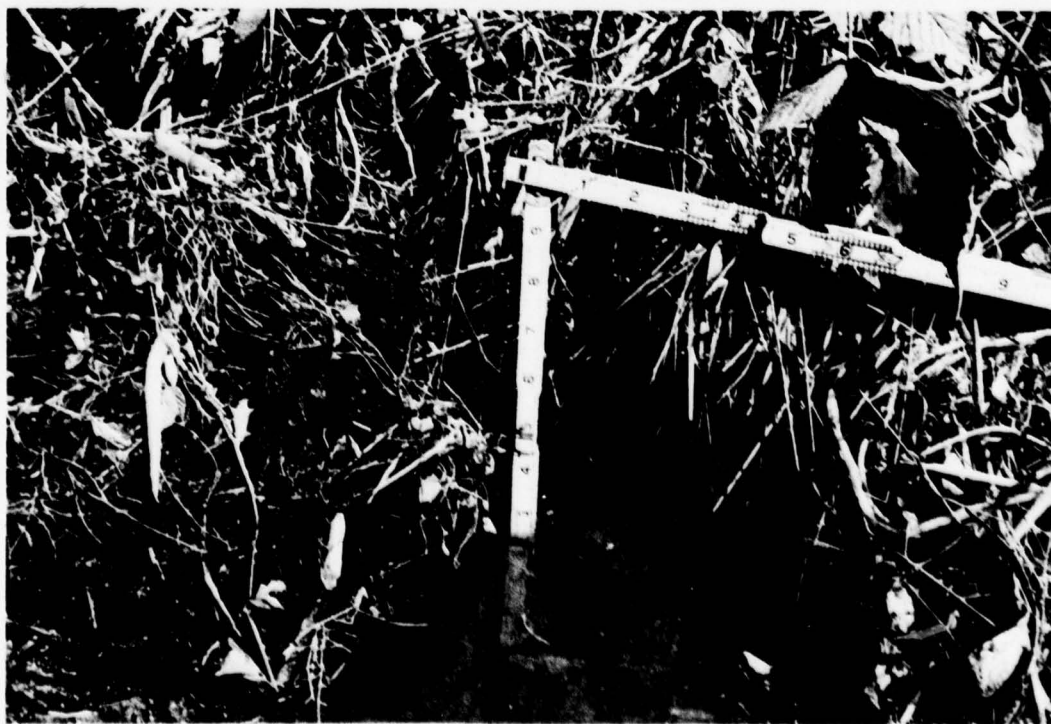
PHOTO 12

- Photo 11 - View Upstream (East) at Right (North) Side Spillway Outlet Showing Wing Wall and Downstream Slope of Dam; 18 Inch Corrugated Metal Pipe in Left Center; Piping Hole (Close-up in Photo 12) Left of Wing Wall Three Feet Above Tailwater at Folded Rule - 9 June 1978
- Photo 12 - Close-up of Piping Hole Encountered in Test Pit at Toe of North Spillway Outlet Wing Wall (Photo 11) - 9 June 1978
- Photo 13 - View Downstream (West) Over East End of Lionshead Lake From Downstream Slope of Point View Dam, Left (South) of Spillway; Ditch Carrying Storm Water and Stream Flow From Left Abutment Area Enters Lake at Left Edge of Photo - 9 June 1978
- Photo 14 - View Downstream (Northwest) Over East End of Lionshead Lake From Southwest Bank - 9 June 1978
